Terry Munson

Activate That Flux!

Moisture absorbed by poorly activated flux residues coupled with other ionic residues can cause failures.

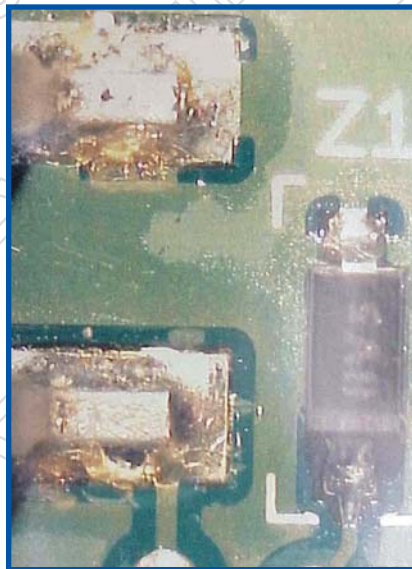
The same component area showed high levels of weak organic acids on all modules examined. Weak organic acids, such as succinic or abetic acid, are generally benign, but can prove detrimental if not fully activated, which permits them to absorb moisture.

This proved to be the case with the failed modules. The WOAs absorbed moisture, which reacted with the chloride to cause a field failure. The chloride on the affected component would not have been so apt to cause a failure if the WOA flux residues had not absorbed moisture from the air. With the application of a current, the moisture and chloride created a corrosion cell.

FIGURE 1: Area of heavy flux residue on the module.

One of the client's issues was incoming component cleanliness. The problem was magnified by not fully activating the flux used in assembly. Components should be monitored for cleanliness as-received.
