Lead-Free First-Article Inspection

Typical process concerns associated with LF alloys for first-article OI and line qualification.

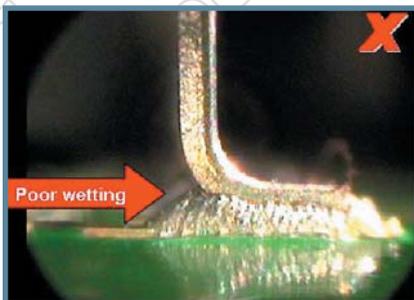
FIGURE 1: Lead-free alloy wetting defect.

fillet formation more difficult to achieve. **Figures 1 and 2** show LF wetting and solder flow problems that do not meet prescribed standards. Ultimately, soldering processes will need better temperature control and minimized temperature delta during reflow.

unable, however, to detect all the predicted LF problems, and must be augmented by board level, 90° optical inspection. The photos shown as **Figures 1 and 2** cannot be taken with the standard 0°, low magnification inspection equipment in use today for first-article inspection.

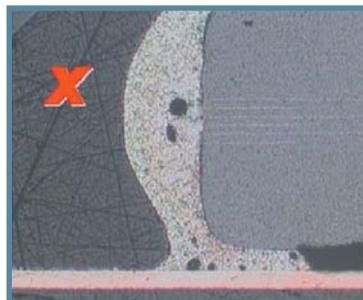
FIGURE 2: Solder flow problem in lead-free joint (Courtesy Zollner).

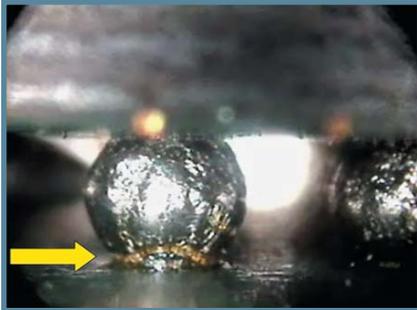
FIGURE 3: Incomplete wetting between BGA ball and pad.

- Incomplete wetting of the BGA ball to the pad will be more prevalent (**Figure 3**).
- More aggressive fluxes under hidden packages (**Figure 4**) leaving residues that must be properly cleaned.
- Micro solderballing under BGAs (**Figure 5**) or other hidden locations

Such problems will be more prevalent in a LF process, and will require more thorough first-article inspection. Moreover, the defects shown in Figures 3 to 8 cannot be detected with standard microscopes and test equipment. If undetected, early field failures and warranty repairs will likely occur.

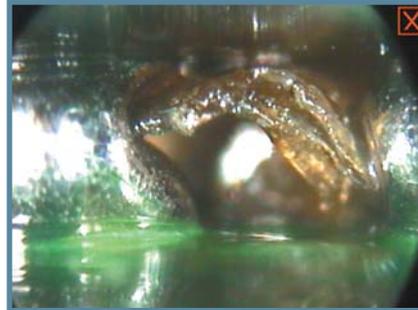
FIGURE 4: Flux residue under package.

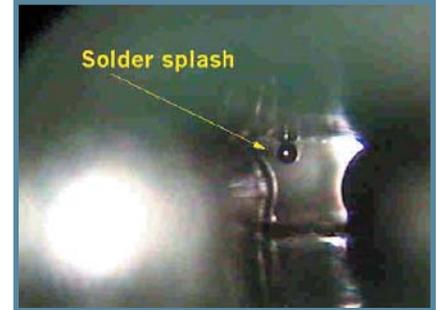
FIGURE 5: Tiny solder balls.

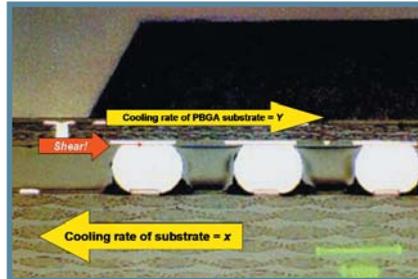
FIGURE 6: Delamination due to CTE mismatch. (Courtesy FhG ISIT)

- Higher process temperatures, which will put greater thermal stress on the PCB substrate and BGA package, Component shear delamination problems resulting from CTE mismatch problems will occur during cooling and solidification (**Figures 6 and 7**).
- PTH fillet lifting (**Figure 8**), a new phenomenon.

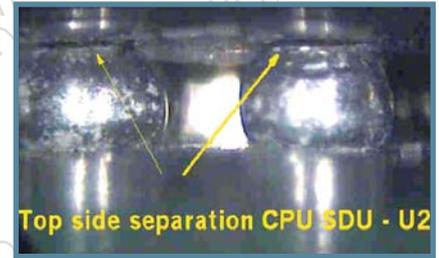
FIGURE 7: Topside separation of package and ball.

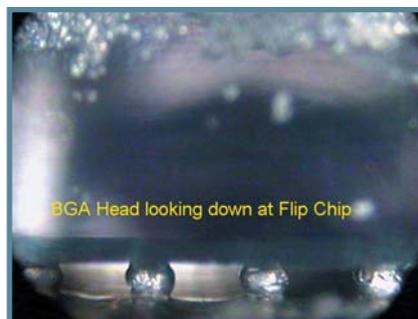
FIGURE 9: New equipment permits a “look up” view of low-profile joints.

Lead-free BGA, CSP and flip-chip soldering will experience additional problems due to smaller process windows and will require better temperature control. Low-profile CSPs and flip chips will require improved inspection capabilities. The iris of current endoscopic or mirror-based optical systems sits approximately 0.300 mm from the surface of the PCB, providing a “look down image” of a flip chip with a standoff height of 0.050 mm. For new devices, the iris is lowered to approximately 0.012 mm, permitting a “look up” view (**Figure 9**) at the topside of the flip-chip joint, and interior joint inspection of low profile μ BGAs and CSPs.
